USING **SCALE WATCHER™** AT BLAST FURNACES TO PREVENT CALCIUM DEPOSITS AND REDUCE MAINTENANCE

Channels and membranes for cooling water around blast furnace stay unobstructed longer

Sidmar-Arcelor enjoys considerable reduction in maintenance and idle time

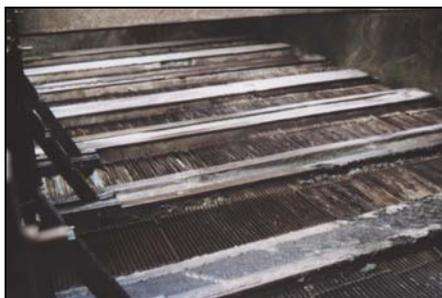
Before

People at Sidmar-Arcelor had decided to try and solve this problem and had thus learned about the **Scalewatcher**TM. They wanted to install one of these devices for a trial period to see if there would be any difference in the accumulation of Calcium deposits. The **Scalewatcher**TM was installed after the membranes and channels had been made fairly clean. During the testing period, two devices were installed: one on the supply pipe leading to the cooling tower, and one on discharge of cooling water to the blast oven (see diagram). The results after six months in operation with the **Scalewatcher**TM were, to put it mildly, amazing. The membranes and channels were just as clean as they had been at the beginning of the trial period.

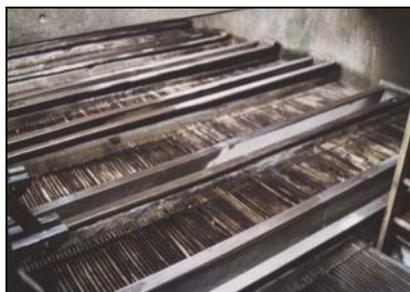
After

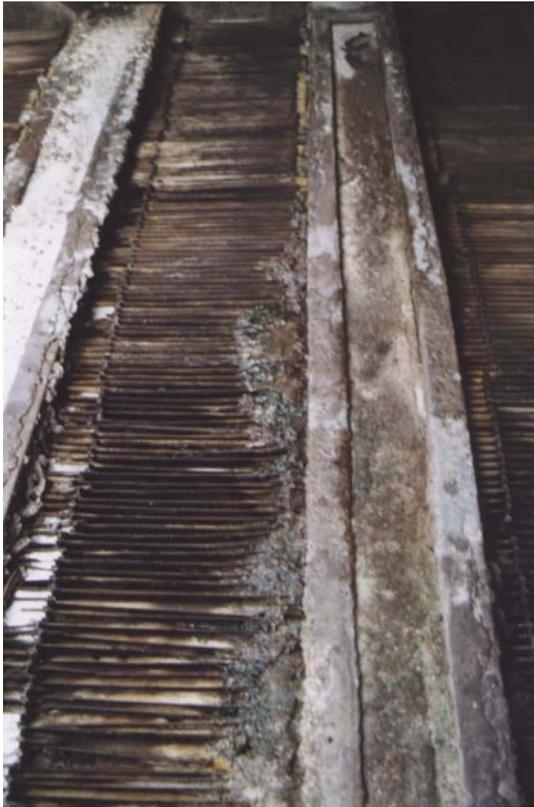
Before

To make the results of the effect of the **Scalewatcher**TM even more obvious, Sidmar-Arcelor and **Scalewatcher**TM removed the devices again after six months. Even after just one month following removal, the membranes and channels were completely covered with calcium deposits again. For the maintenance people at Sidmar-Arcelor, this was the indisputable proof that the **Scalewatcher**TM really does have an extremely beneficial effect when it comes to preventing the accumulation of Calcium deposits. By now, the blast oven's cooling system is not the only place where a **Scalewatcher**TM is in operation at Sidmar-Arcelor. The company also had the same device installed in the cooling system for its rolling mill at the location where the rollers roll the produced steel into thin plates.

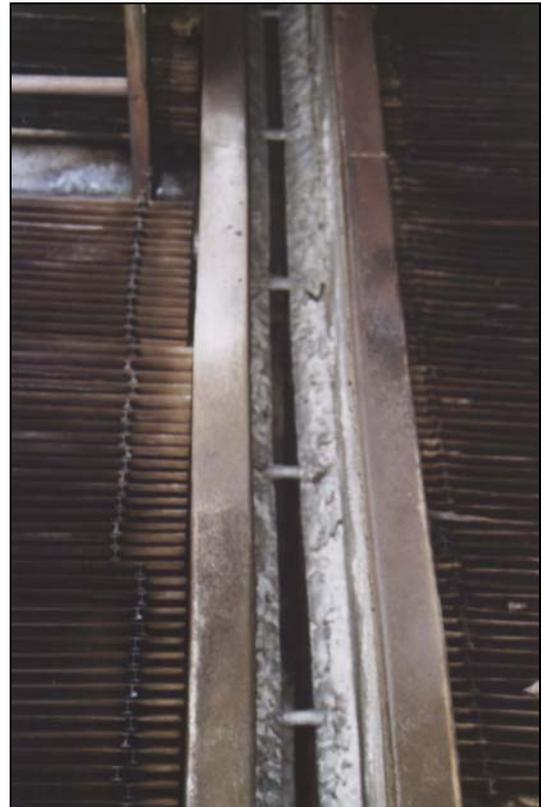
After
